RAILWAY INVESTIGATION REPORT

R01Q0010

MAIN TRACK DERAILMENT

CANADIAN NATIONAL TRAIN NO. G-894-31-14

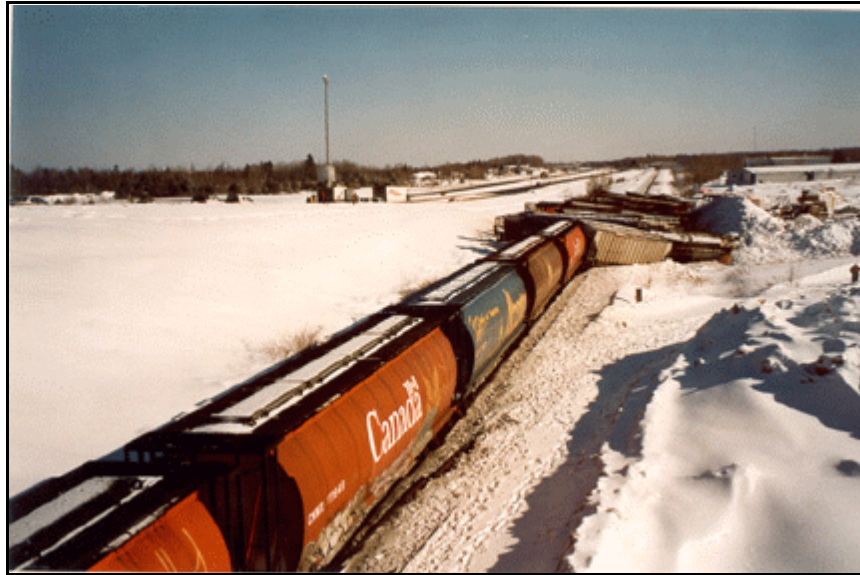
Figure 1. View of the accident site

The 57th car remained upright, 788 metres east of the main derailment area; its trailing truck derailed on the south side of the main track. The 23 cars that followed derailed in an accordion pattern (see Figure 1) over a distance of 64 metres, directly east of the M-211 turnout, on property belonging to a construction materials business adjacent to the right-of-way. The last derailed car remained upright, with its truck derailed on the south side of the track. The signal bungalow, located east of the M-211 turnout, as well as a communications tower belonging to CN, were destroyed. The underground fibre-optic cable was severed.

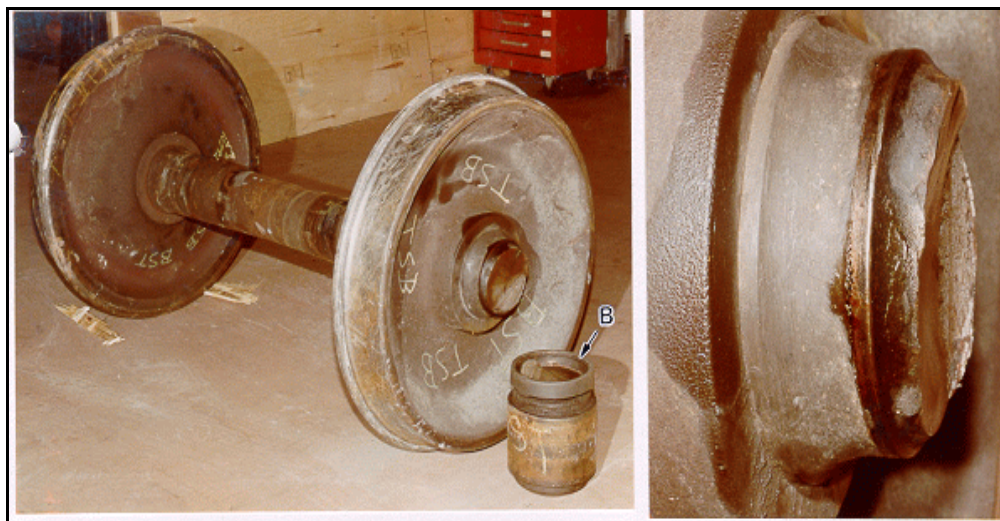
Figure 2. Broken axle and section of journal including roller bearing

A section of a broken axle journal, with its roller bearing (see Figure 2), was found in the ditch on the south side of the track, at Mile 16.25; it originated from car CNWX 107921, the second derailed car. The car in question was a covered hopper car made of aluminum, with a light weight of 41 000 lb (20 045 kg) and maximum loaded weight of 220 000 lb (100 000 kg). The car's shipping record indicated that it was at its maximum load weight at the time of the derailment.

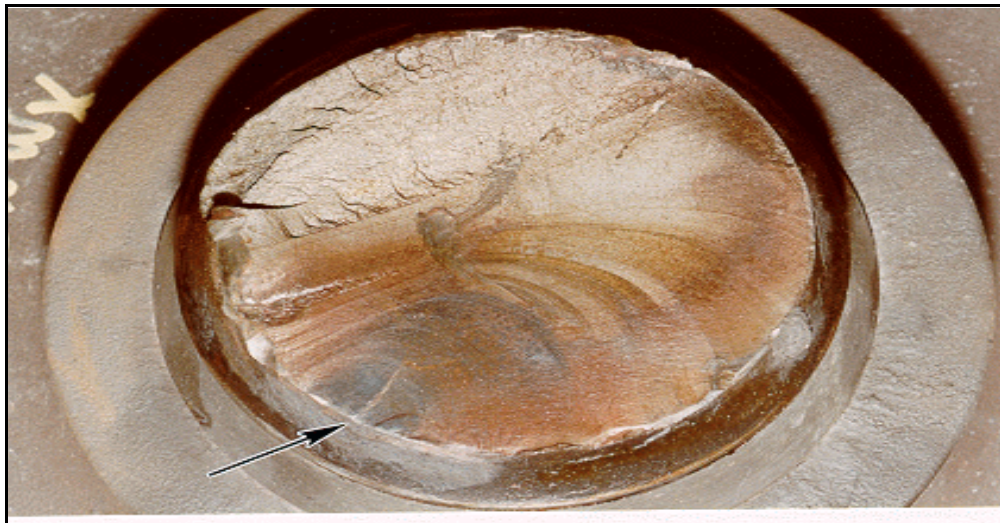
The sections of axle were sent to the Transportation Safety Board of Canada (TSB) Engineering Laboratory for analysis. An examination (Report No. LP 11/01) revealed the presence of a fatigue fracture covering over 65 percent of the fracture surface (see Figure 3). This fracture was first found in numerous crack initiation sites in the axle journal fillet and in the journal box dust guard (axle journal fillet), and coincided with corrosion pitting. The fracture surfaces were highly oxidized, but there were no signs of overheating on any of the components. According to the TSB database, 7 axle fractures occurred in Canada in similar circumstances to this accident between 1998 and 2000 (corrosion pitting which led to fatigue cracking and ultimately to axle failure).³

The lining used to protect the axle journal fillet area had lost some of its flexibility and had completely dried out; the lining used was an asphalt-based anti-oxidation coating approved by the Association of American Railroads (AAR), a lining currently used on axles. The bearing ring, the cones and the axle roller bearings showed signs of spalling on the fracture surface.

Figure 3. Fracture surface of the axle; the arrow shows the origin of the fracture.

According to the results of the analysis conducted by the TSB Engineering Laboratory, the axle broke as a result of a fatigue fracture that originated in the axle journal fillet and that coincided with corrosion pitting. Since the axle fillet area is subjected to high stresses, and corrosion pitting acts as stress raisers, the number of loading cycles that the axle could withstand was decreased, leading to the initiation and development of fatigue fractures, and consequently, the failure of the axle.

Corrosion pitting on the axle journal fillets, as well as spalling on the bearing ring, cones and axle roller bearings, indicate that moisture penetrated and accumulated in the area. This moisture could have been the result of condensation that forms while the bearings cool down, but it could also have penetrated through the protective coating, which had completely dried out and become susceptible to moisture. For this reason, quality control during the application of the coating is essential to ensure protection against corrosion pitting.

Since these fractures cannot be detected during safety inspections, given that the axle journal fillet area is covered by the roller bearing backing ring, it is essential that a check be made for possible internal defects in the axle journal fillet in order to identify sub-surface fractures and reduce associated risk of axle failures.
